# Minimising prevalence and severity of croup lesions in cart-pulling donkeys by adjusting cart shaft length in Jacobabad Pakistan

The Brooke Pakistan

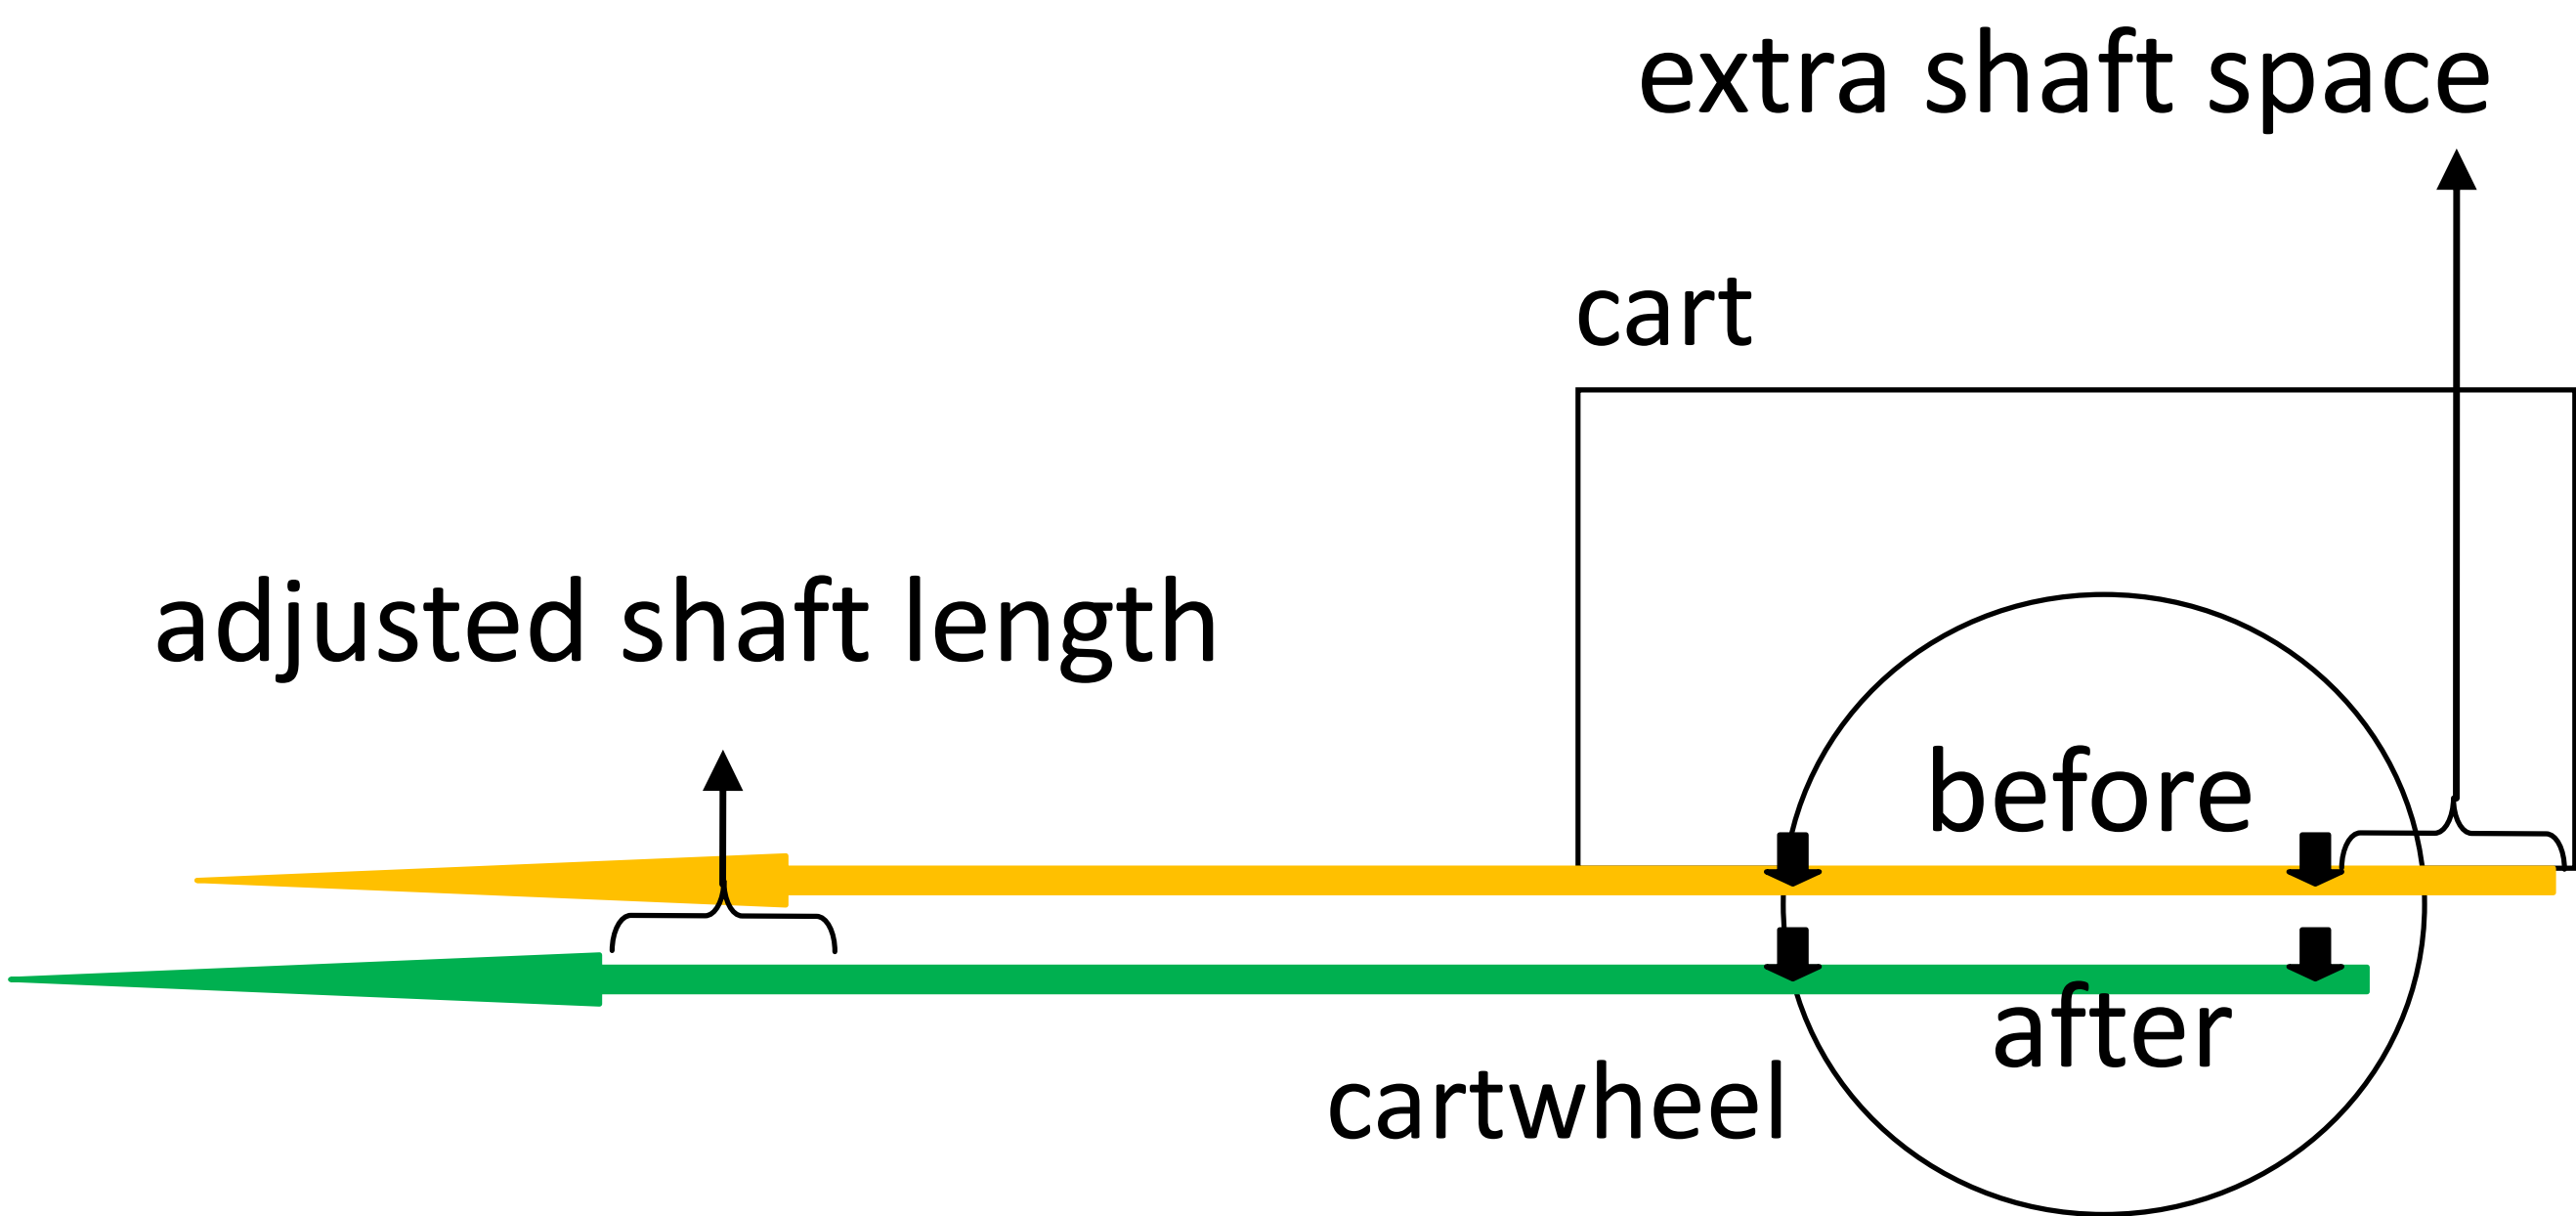
**Figure 2:** Illustration of cart shaft length adjustment to avoid croup lesions. The shaft length adjustment will allow an additional 15–30cm space

- A baseline study was undertaken to assess prevalence of croup lesions
- Twenty-eight donkeys with croup lesions (at least skin broken) were selected for the pilot study
- Croup lesion length and severity level were recorded in addition to shaft length
- The cart was referred to a nearby cart maker (Figure 3)
- An increase in shaft length (15–30cm) was suggested, keeping in mind animal size and cart capacity (Figure 2)
- Data on lesions were collected fortnightly over two months

- A survey on 200 cart-pulling donkeys reported high (60%) prevalence of croup lesions in Jacobabad
- The survey showed that 95% community members attributed croup lesions to collisions against the cart
- Twenty-eight donkeys with croup lesions were selected
- Shaft length was increased by between 15 and 30 cm allowing for donkey size and the cart's capacity for shaft length adjustment
- A significant decrease was observed in both prevalence and severity of croup lesions in target donkeys

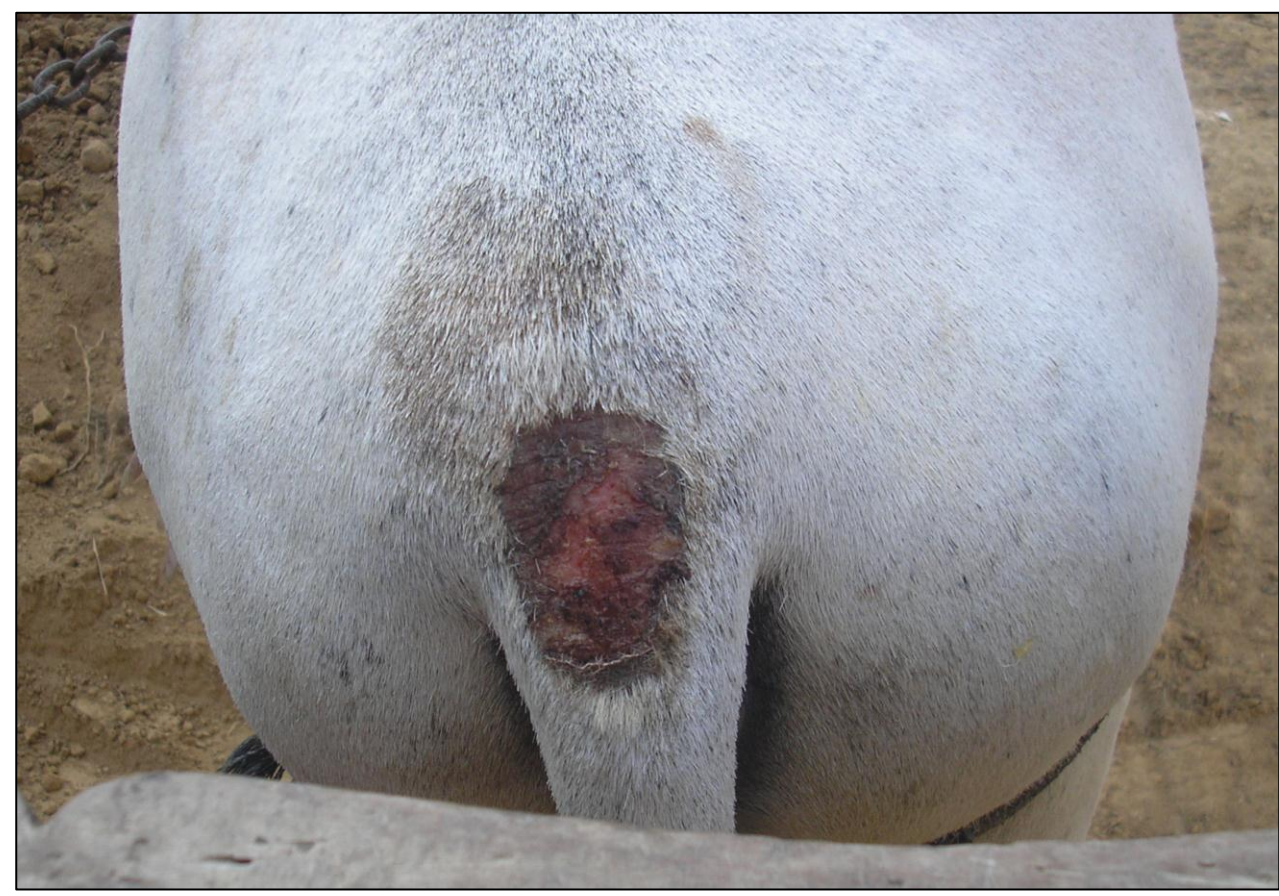
**Figure 1:** A cart donkey with a croup lesion

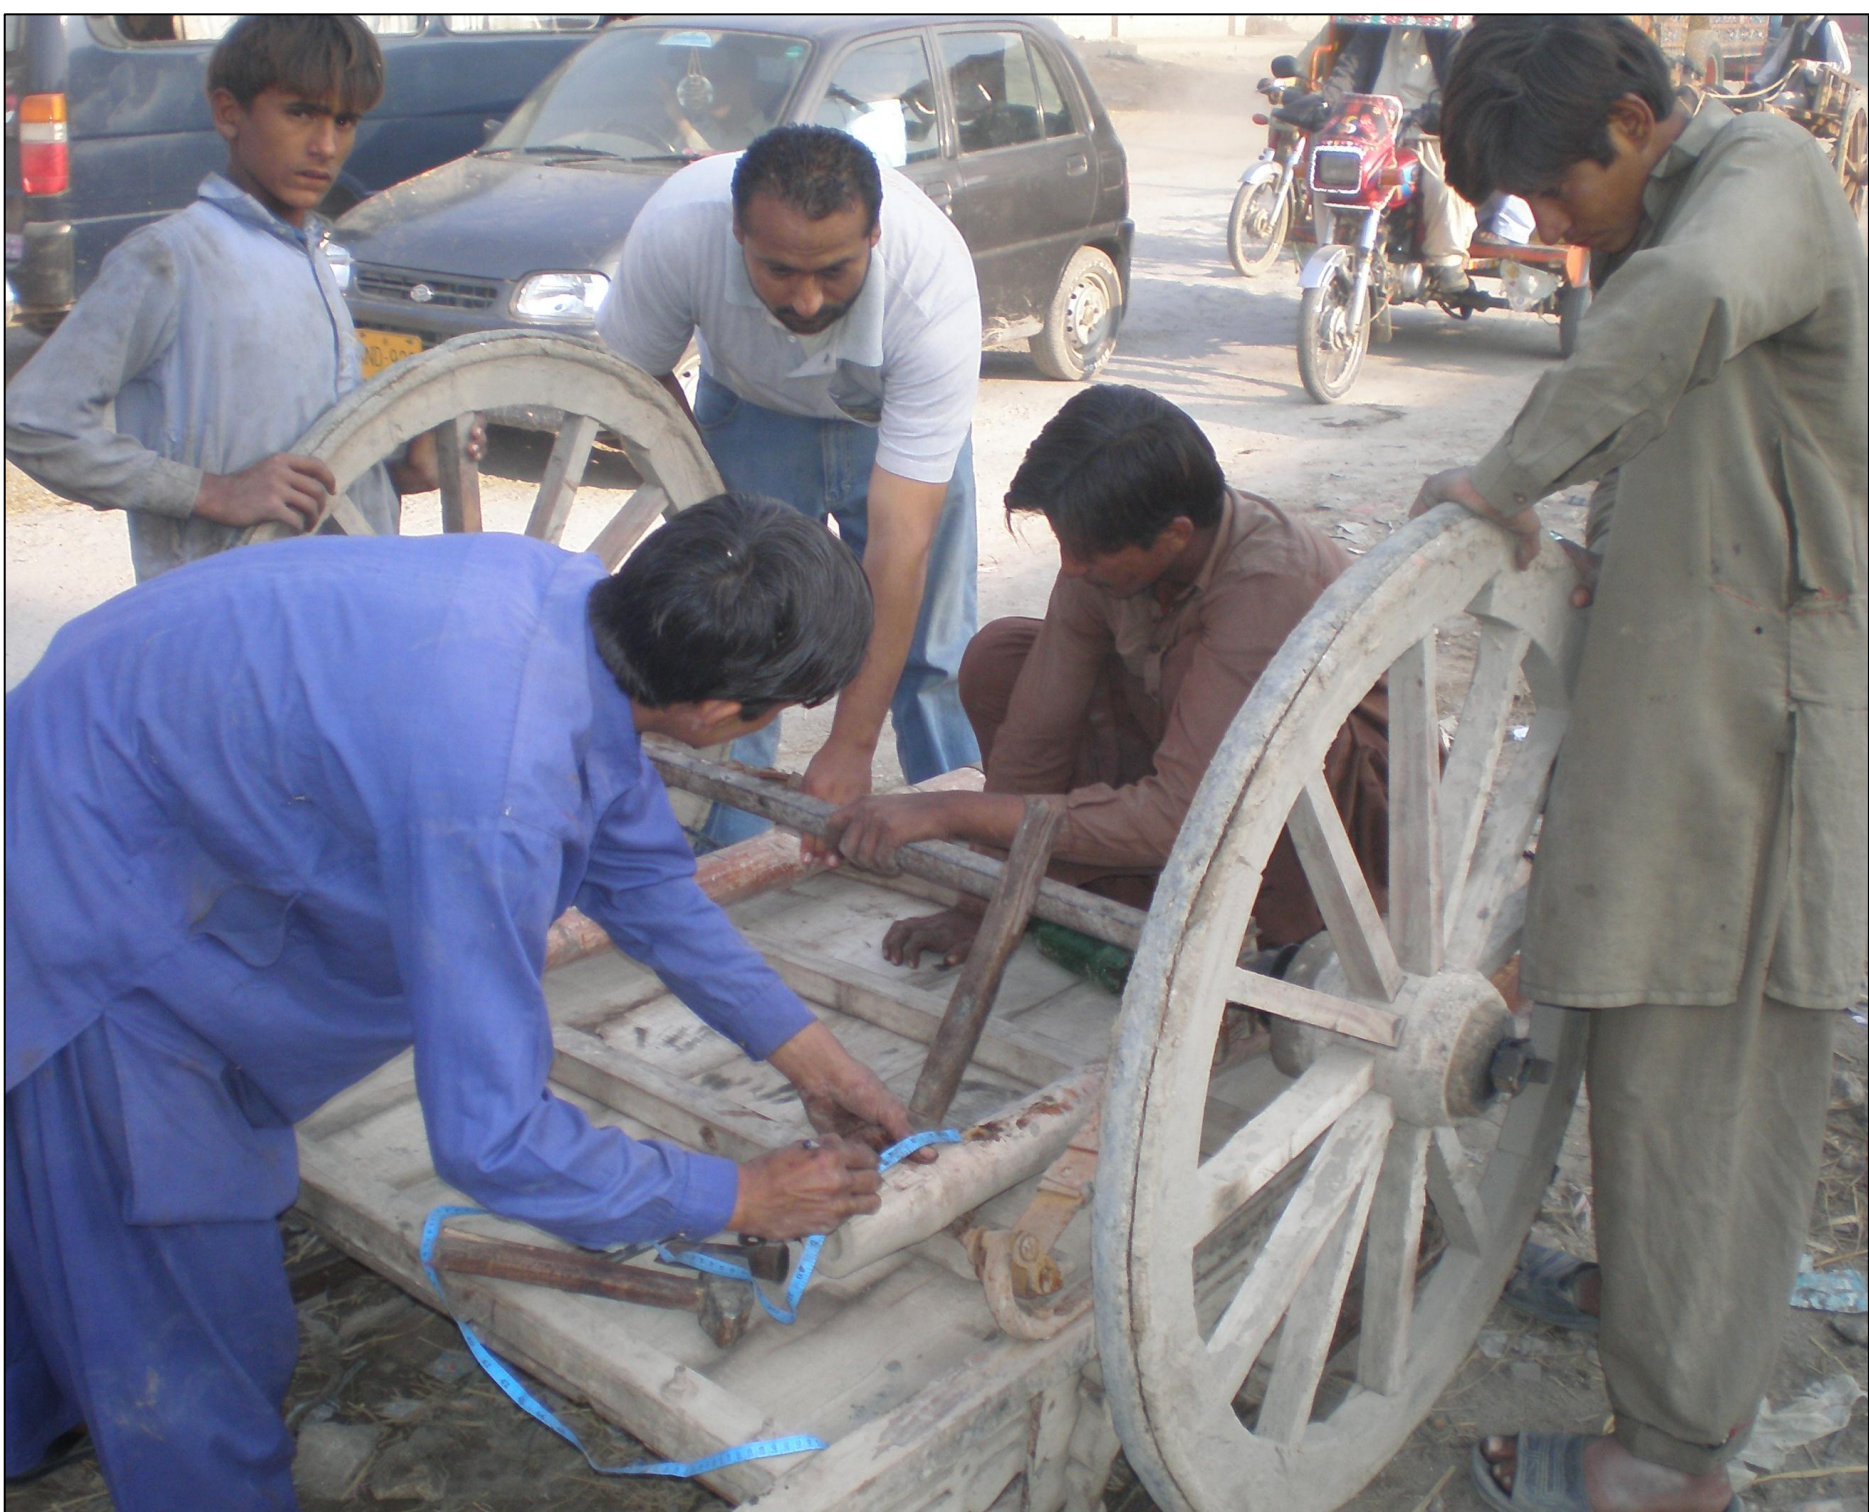
**Figure 3:** A local cart maker is making the advised shaft length adjustment

Over 60% donkeys in the initial survey had croup lesions, and over 95% owners and cart makers agreed croup lesions were caused by collision of the cart against the donkey. Both community members and cart makers, however, thought these lesions could be minimised through adjusting the shaft length, which had not been previously attempted (Figure 3).
